PROCESSTEC

ViscoTwin

R+W Disengaging Coupler

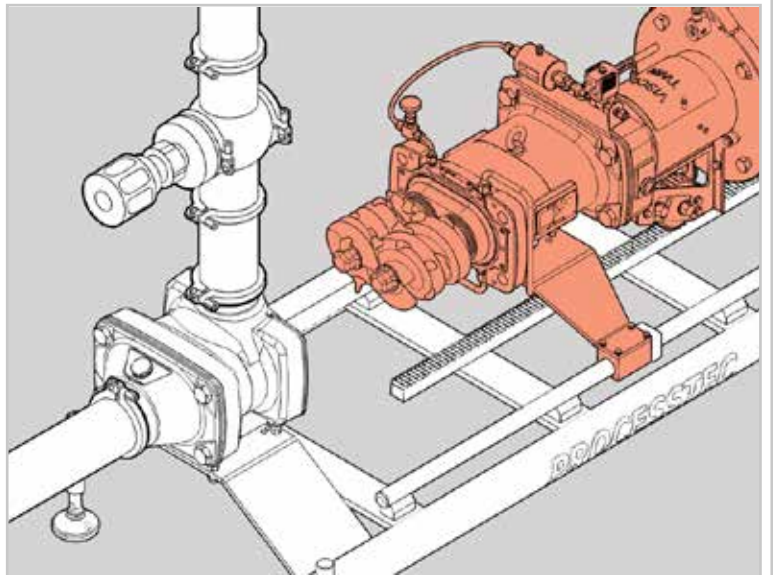
STEP 1)

Disconnect the Pump Housing Bolts (Pos. 1016) from the Pump Housing (Pos. 2530).

Using the Frame #4 Gear Console underneath the Lantern (Pos. 3000), slide the Pump/Lantern/Motor all the way back until the Bearing Housing Sliders reach the Stop Brackets on Frame #4.

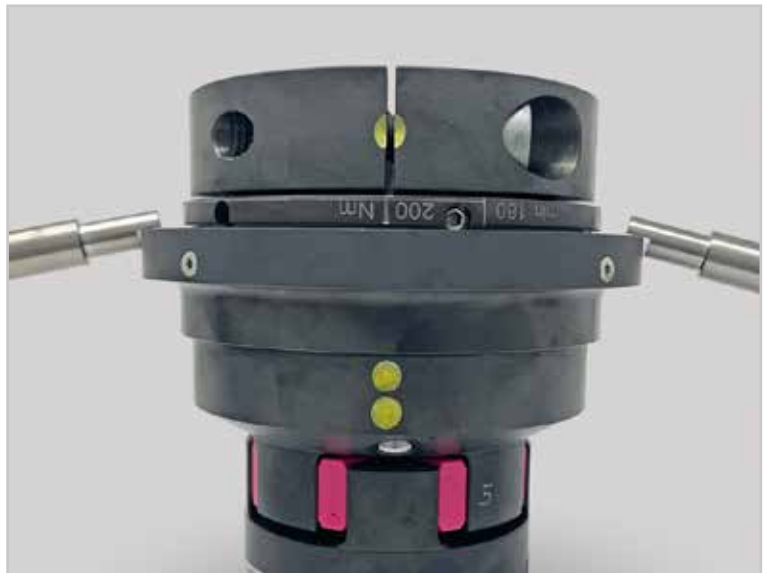
STEP 6)

Remove the TWO (2) Breakaway Coupler Levers (Pos. 3030) that are threaded on the side of the Lantern (Pos. 3000). These tools will be used to Re-engage the R+W Coupler.

Arrange the flat surfaces of the tips so that they will be able to rest against the backside of the Motor Hub Outer Ring.

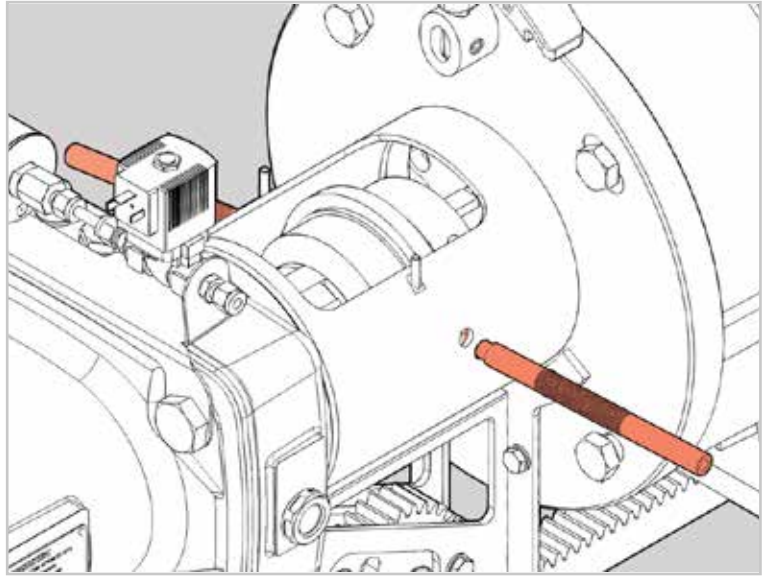
STEP 7)

Insert both Breakaway Coupler Levers (Pos. 3030) into the small holes on the sides of the Lantern (Pos. 3000) that are closest to the Motor (Pos. 3003), with the flat surfaces of the tips touching the Motor Hub Outer Ring.

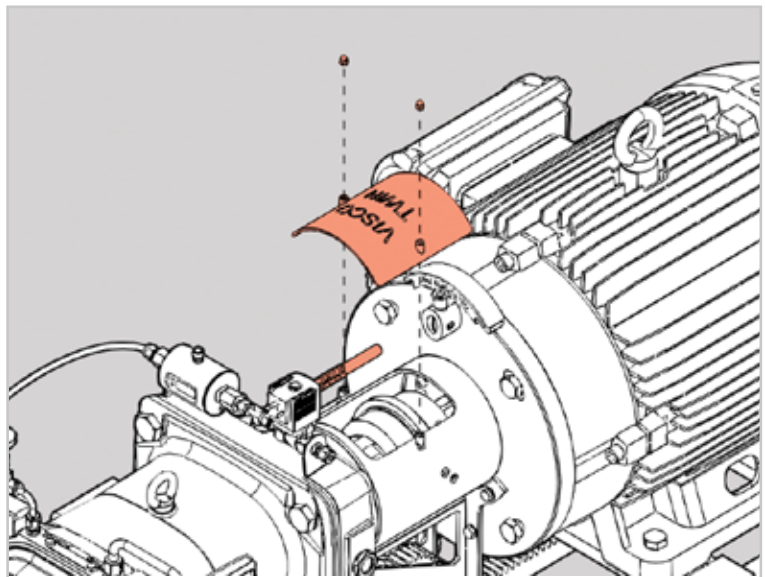
STEP 10)

Replace the Re-engagement Tools (Pos. 3030) onto the Lantern (Pos. 3000), reattach the Lantern Safety Shield (Pos. 3001) and then fix the Cap Nuts (Pos. 3002) in place.
